# CRYSTAL RIVER RESTORATION

RIPARIAN RESTORATION PLAN & ECOLOGICAL INTEGRITY ASSESSMENT  
GARFIELD COUNTY, COLORADO

Prepared for: The Town of Carbondale  
Prepared by: DHM Design Corp. and River Restoration  
311 Main Street, Suite 102, Carbondale, Colorado 81623

November 2018

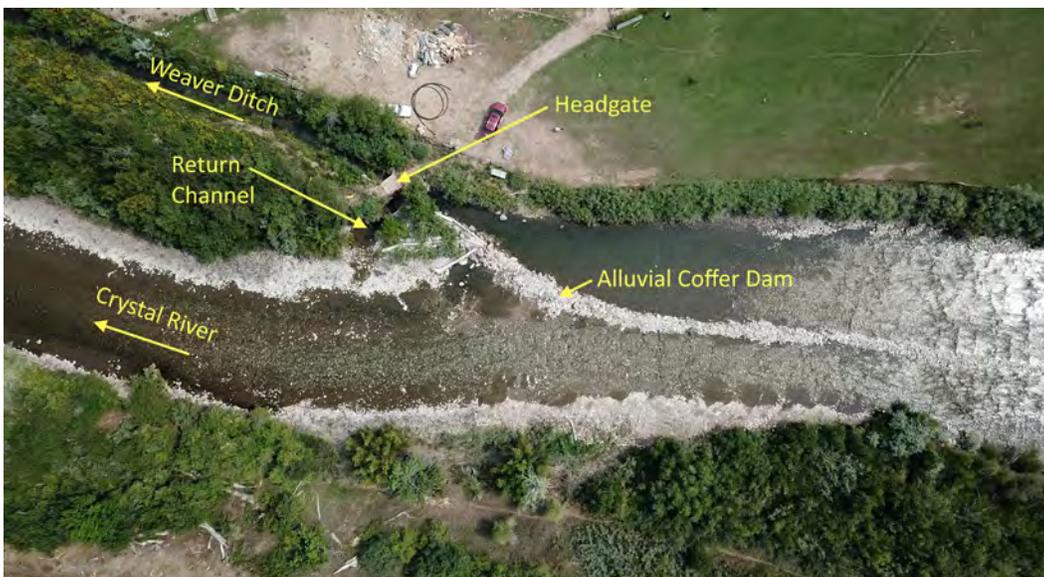
Image 3-1 Alluvium dam, boulder grade control, concrete headgate structure, and the beginning of the Weaver Ditch.

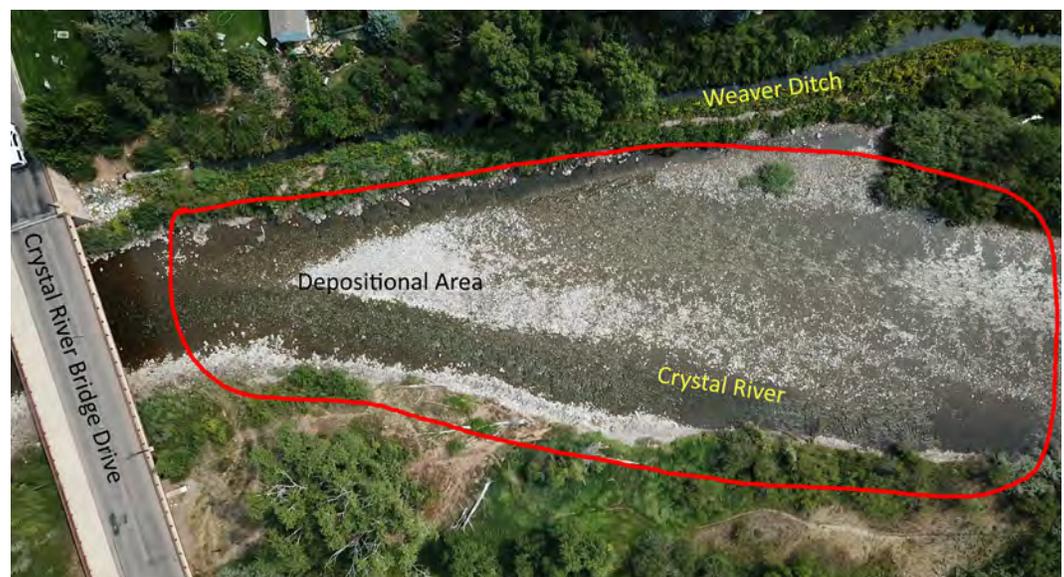
Image 3-2 Alluvium deposition area

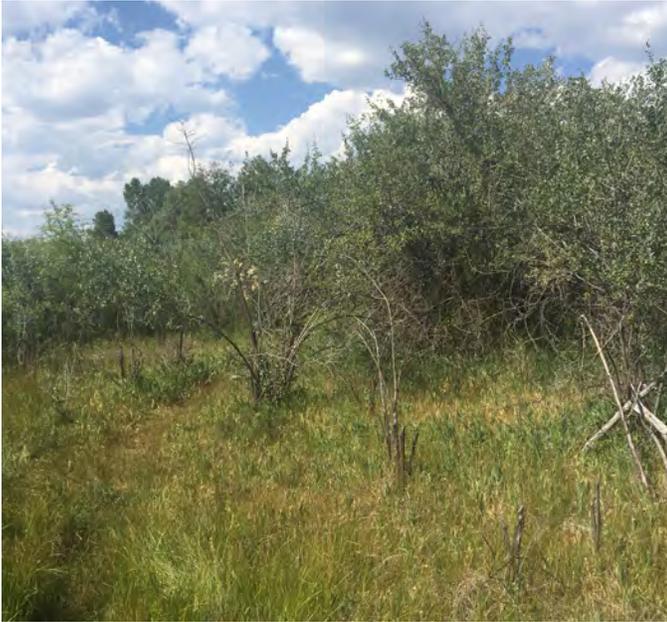
Image 3-3 Example of the riparian shrublands within the project area

The Riparian Scrubland / Scrub Shrub Wetland zone within the project area is dominated by woody vegetation less than 6 m (20 feet) tall. The species include true shrubs, young trees, and trees or shrubs that are small or stunted because of environmental conditions. The most dominant vegetative class of within the Project Area at 10.3 acres, this system occurs on both sides of the river and includes the following dominant vegetation types: Silver buffaloberry (*Shepherdia argentea*), Alder (*Alnus incan subsp. tenifolia*), Twinberry/bush honeysuckle (*Distegia involucrata* (*Lonicera*)), Redosier dogwood (*Cornus sericea* (*C. alba*)), Red haw (*Crataegus erythropoda*), Sandbar willow (*Salix exigua*), Mountain willow (*Salix monticola*), Green rabbitbrush (*Chrysothamnus viscidiflorus*).

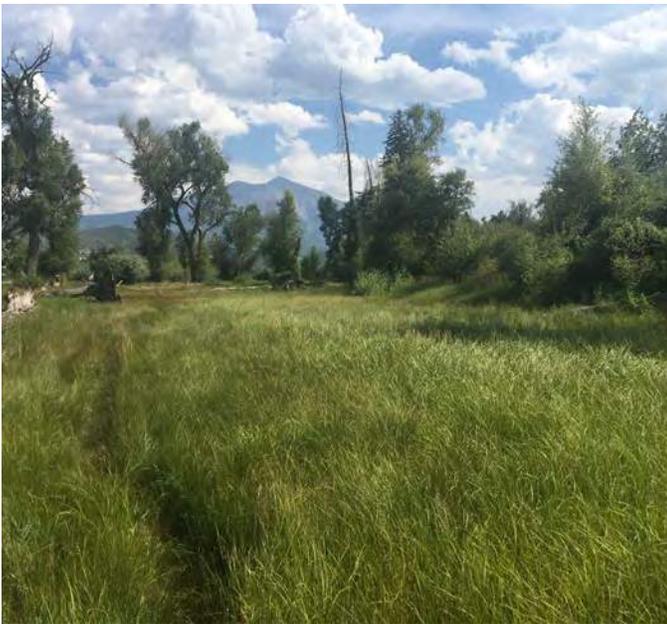
Image 3-4 Palustrine emergent wetland in the foreground with riparian forest in the background

along the toe of the slope at the north side of the Project Area and again towards the south side, where the wetland is large and is of very high quality, with significant vegetative composition, diversity and structure. The total acreage for this type of wetland is 2.7 acres. Dominant vegetative species for this type of system within the project area include: Woolly sedge (*Carex pellita*), Nebraska sedge (*Carex nebrascensis*), Beaked sedge (*Carex rostrata*), Nodding rush (*Isolepis cernua*), Baltic rush (*Juncus articus subs. Ater(=J.balticu)*), Colorado rush (*Juncus confusus*) and Alpine bluegrass (*Poa alpina*).

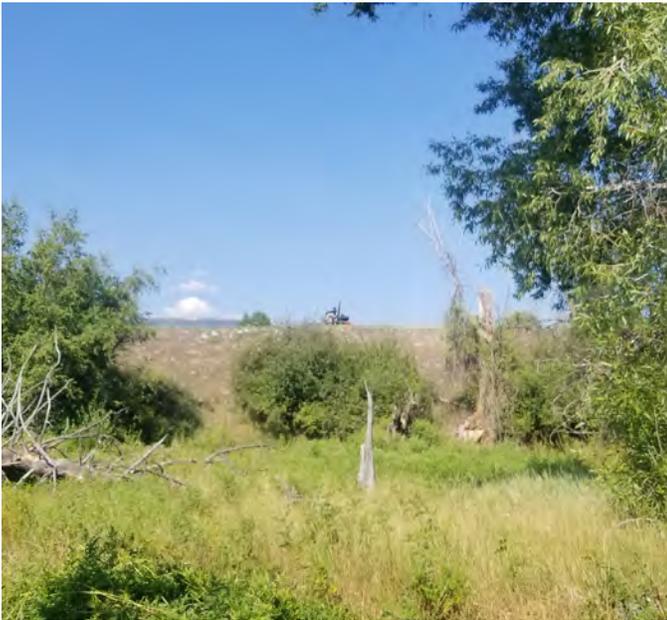
Image 3-5 Upland area of the site bordering the River Valley Ranch Golf Course

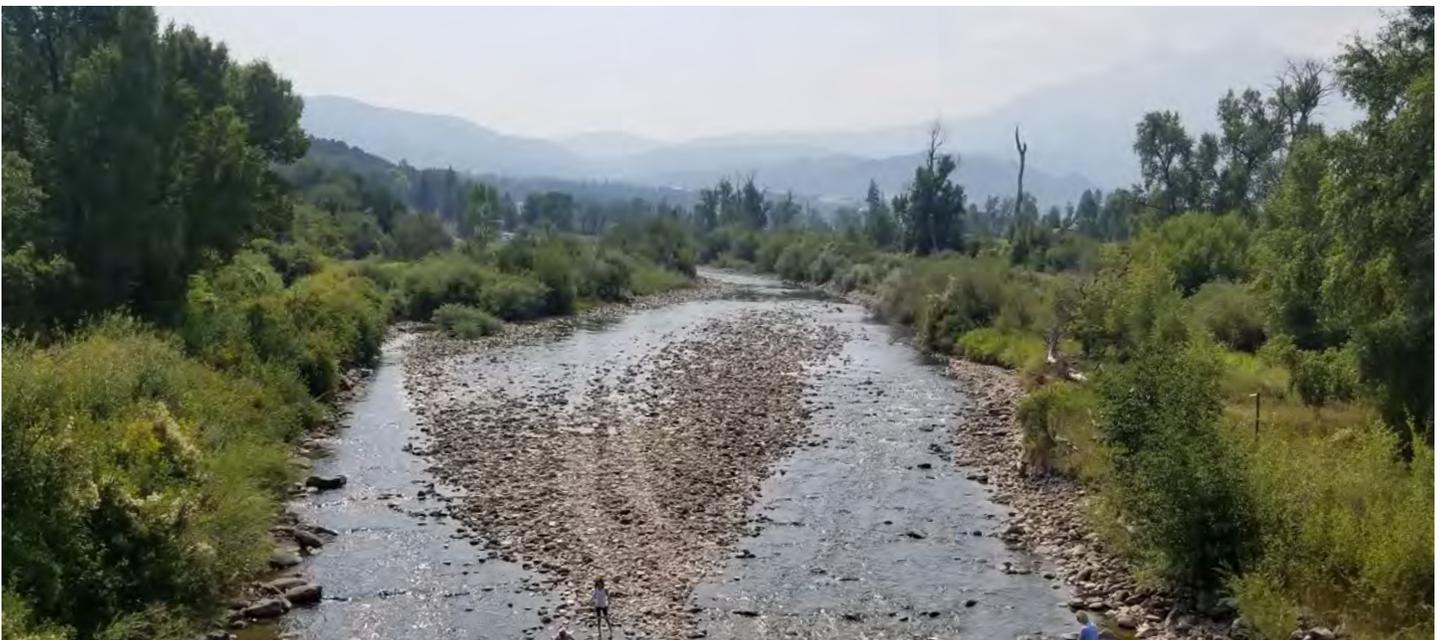
Image 3-7 The wide shallow course of the river through the project area seasonally limits fish habitat and angling potential

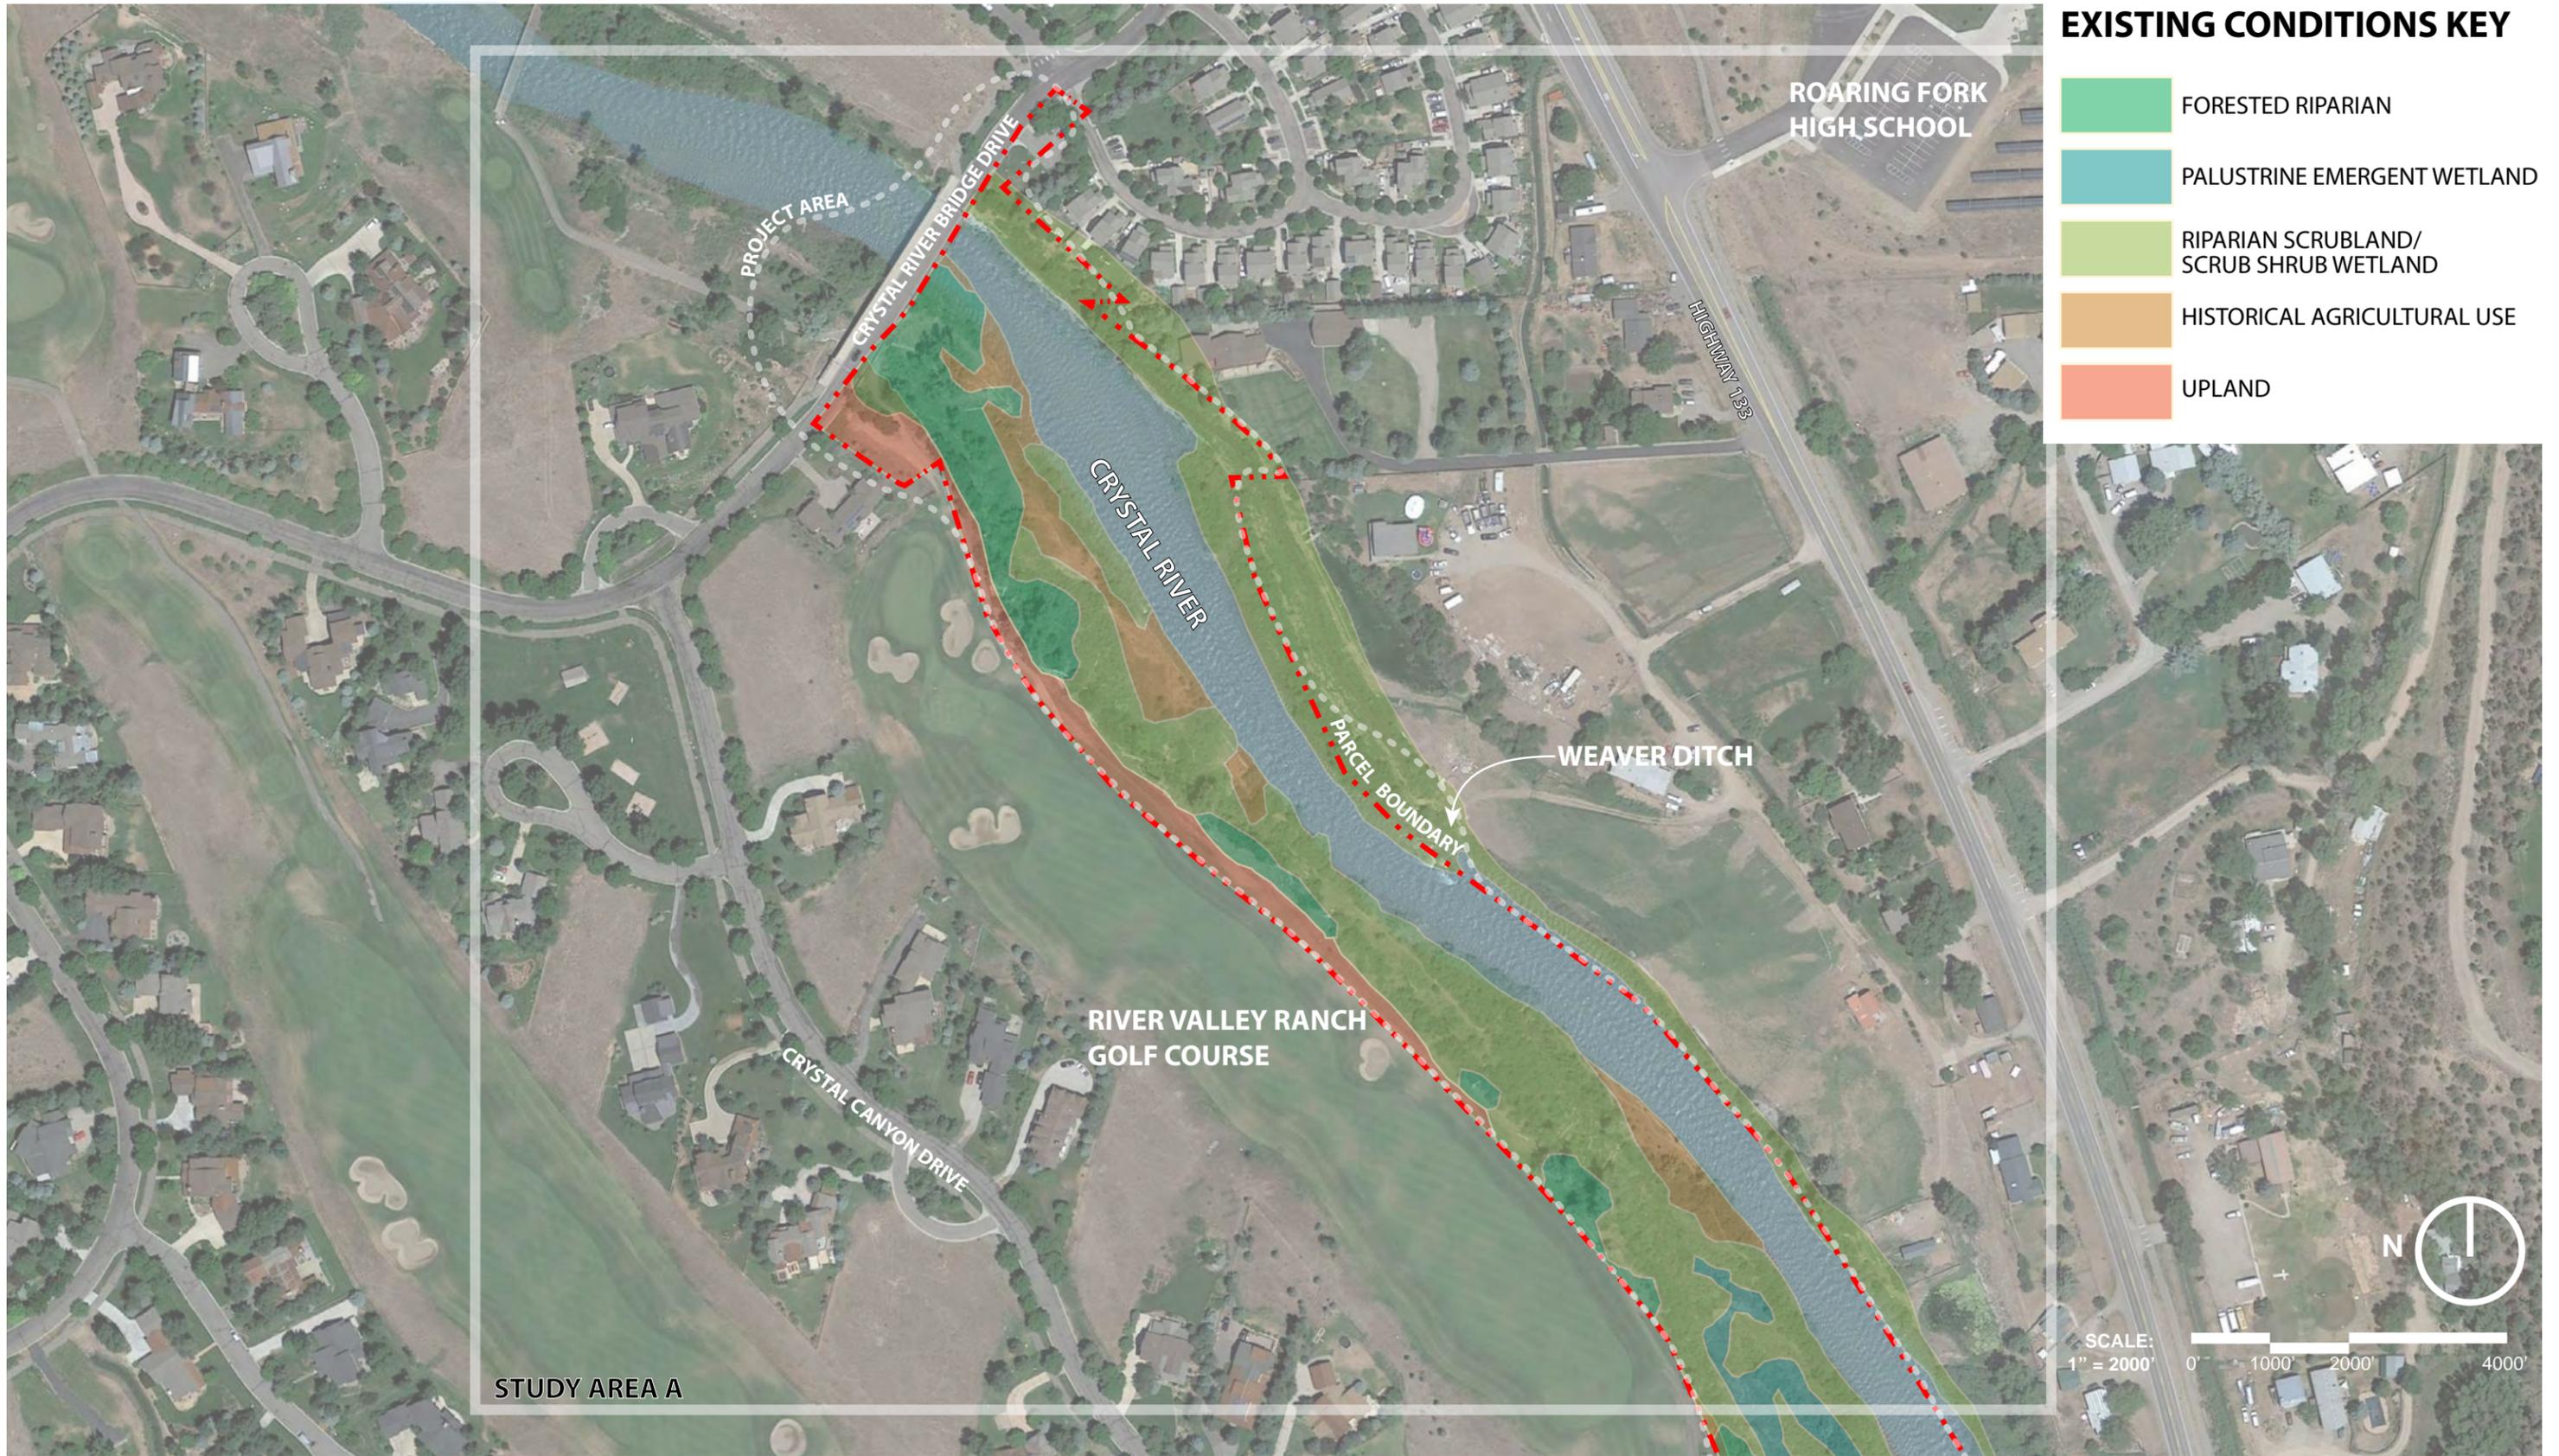
STUDY AREA A

- FORESTED RIPARIAN
- PALUSTRINE EMERGENT WETLAND
- RIPARIAN SCRUBLAND/  
SCRUB SHRUB WETLAND
- HISTORICAL AGRICULTURAL USE
- UPLAND

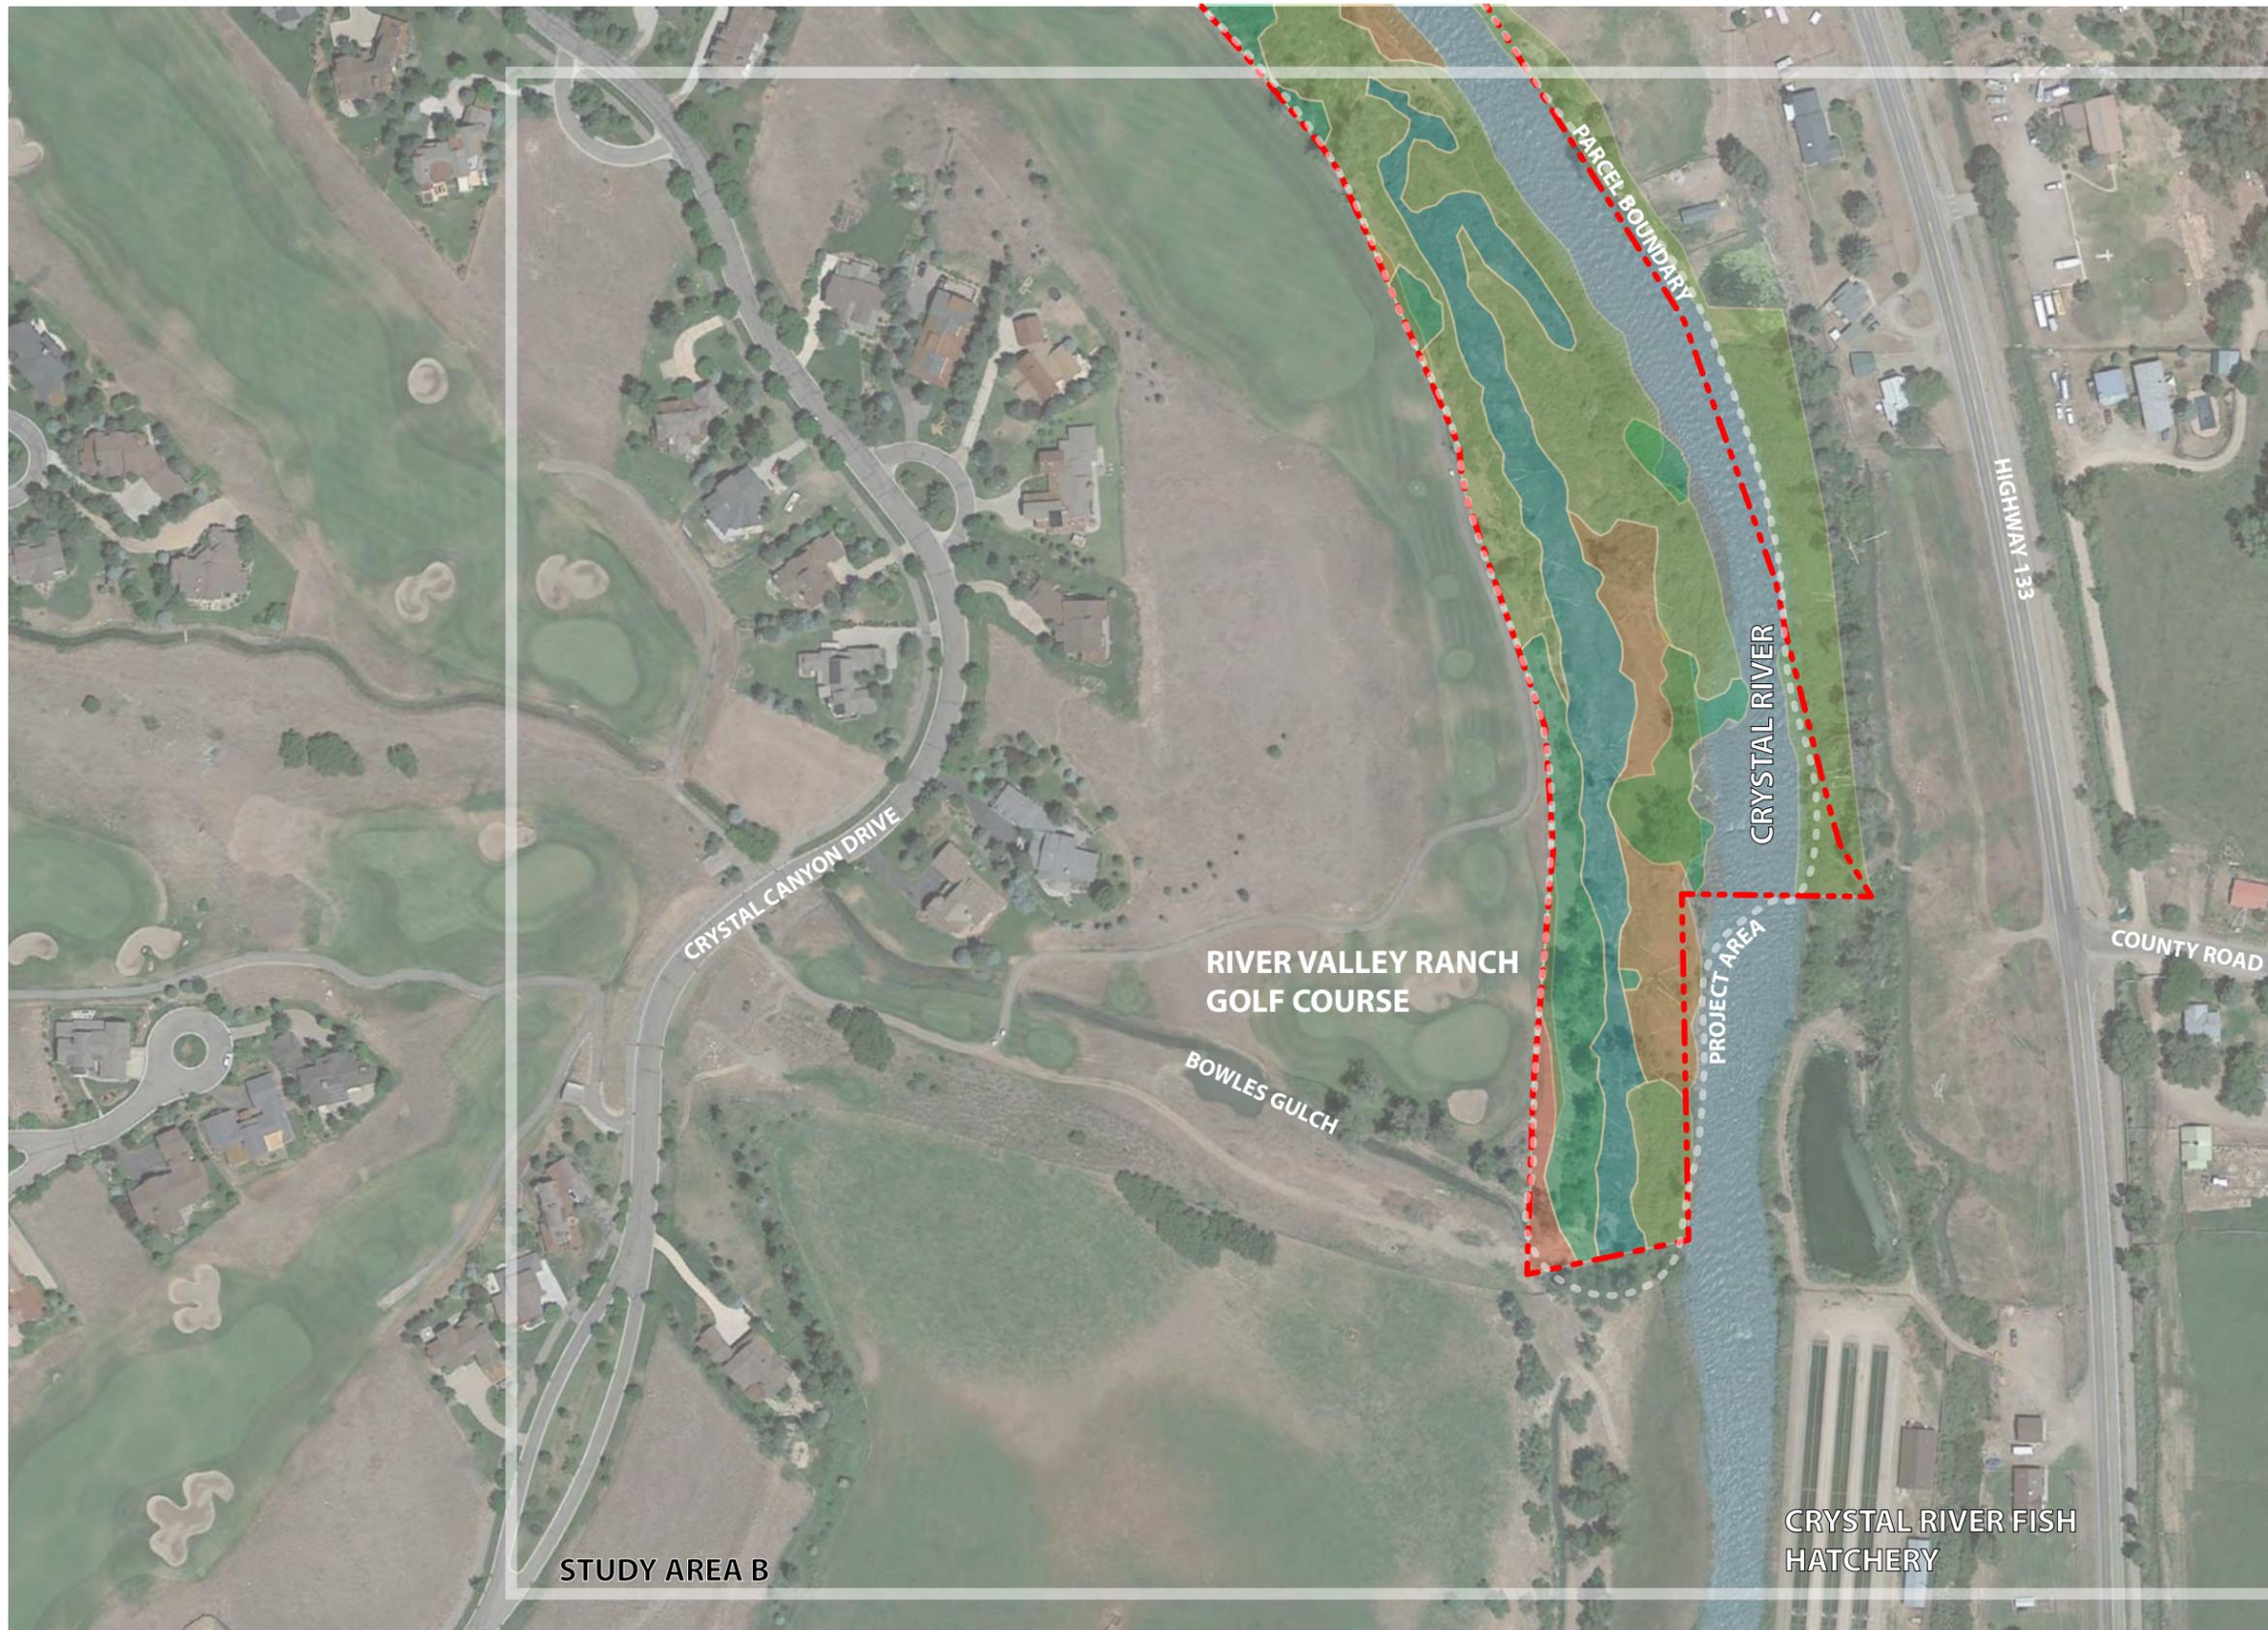
**EXISTING CONDITIONS KEY**

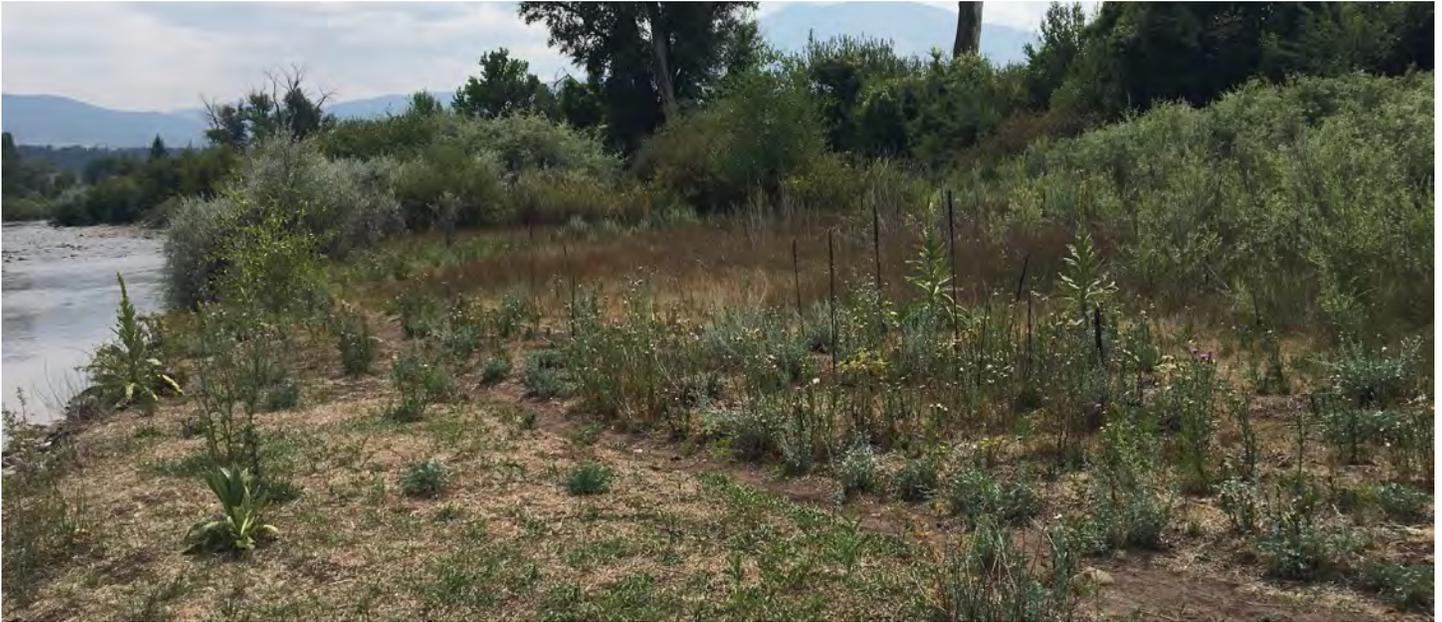
Image 4-1 This image demonstrates highly degraded ecologic conditions near the river on the left side of the photograph. This is an area recommended for riparian creation. Near the center of the photo, healthy forbes indicate an intact wetland which could be enhanced.

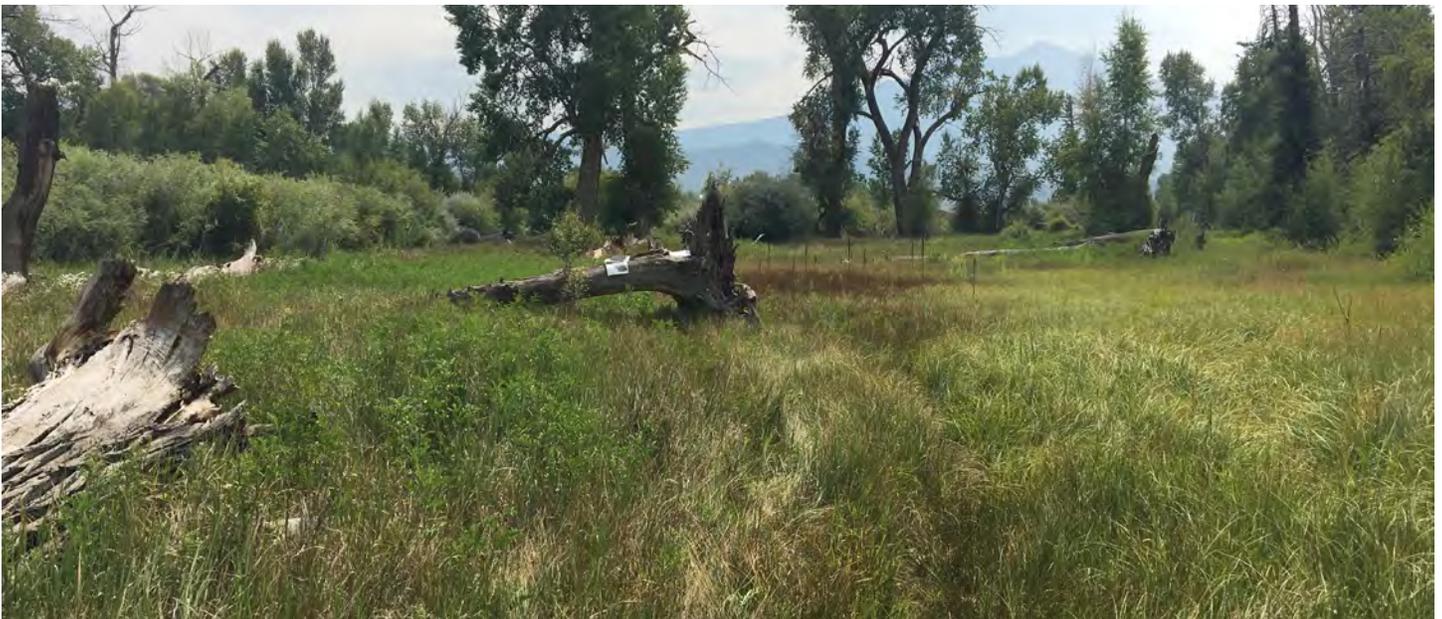
Image 4-2 A high quality wetland can be seen on the right side of the image. This area would be recommended for wetland preservation. On the left side of the image, closer to the Crystal River there is an area recommended for wetland creation

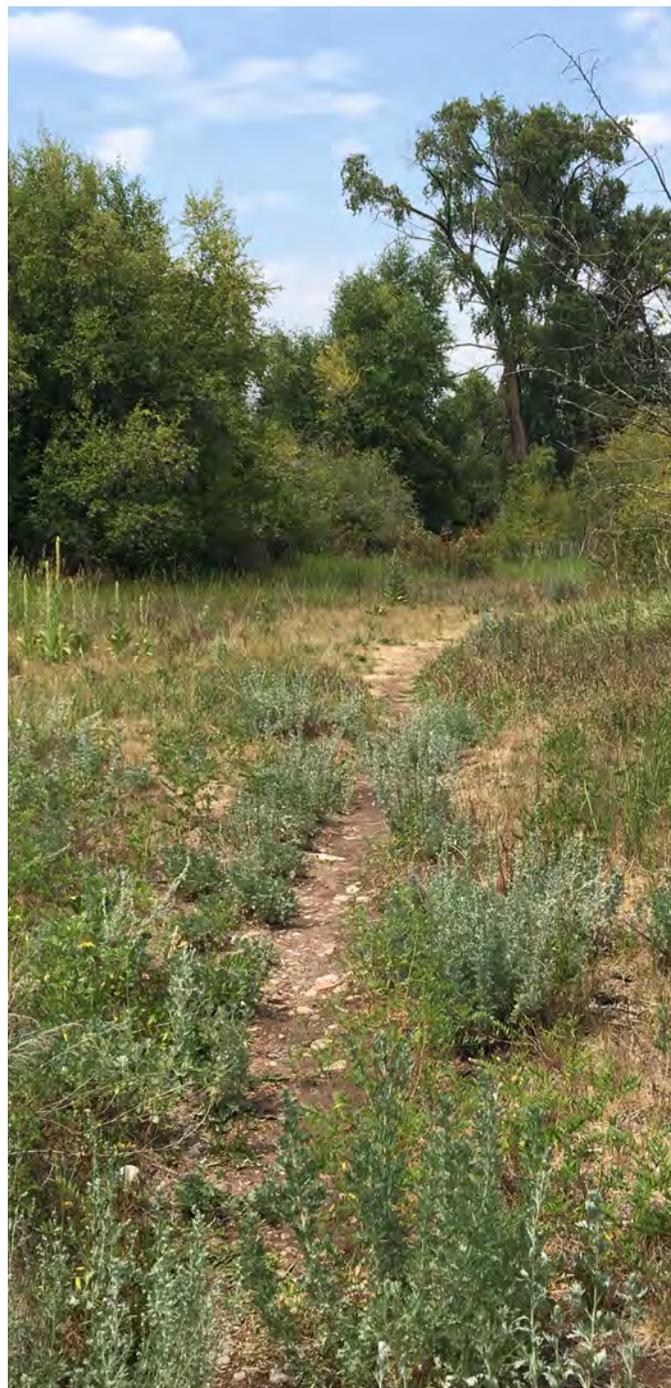
Image 4-3 This location of the assessment area has mature trees and shrubs suitable for riparian preservation. The herbaceous ground cover is mostly noxious weeds making it a candidate for riparian creation

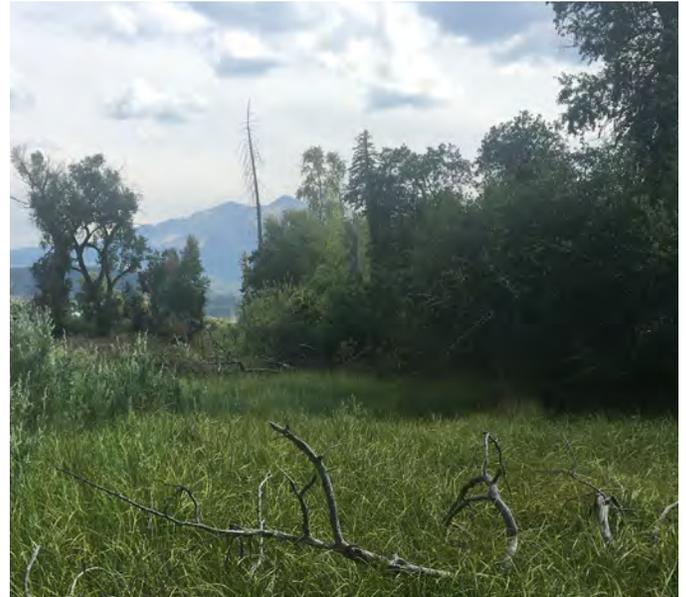
Image 4-4 An example of healthy PER wetlands and riparian shrublands. Both areas are recommended for preservation

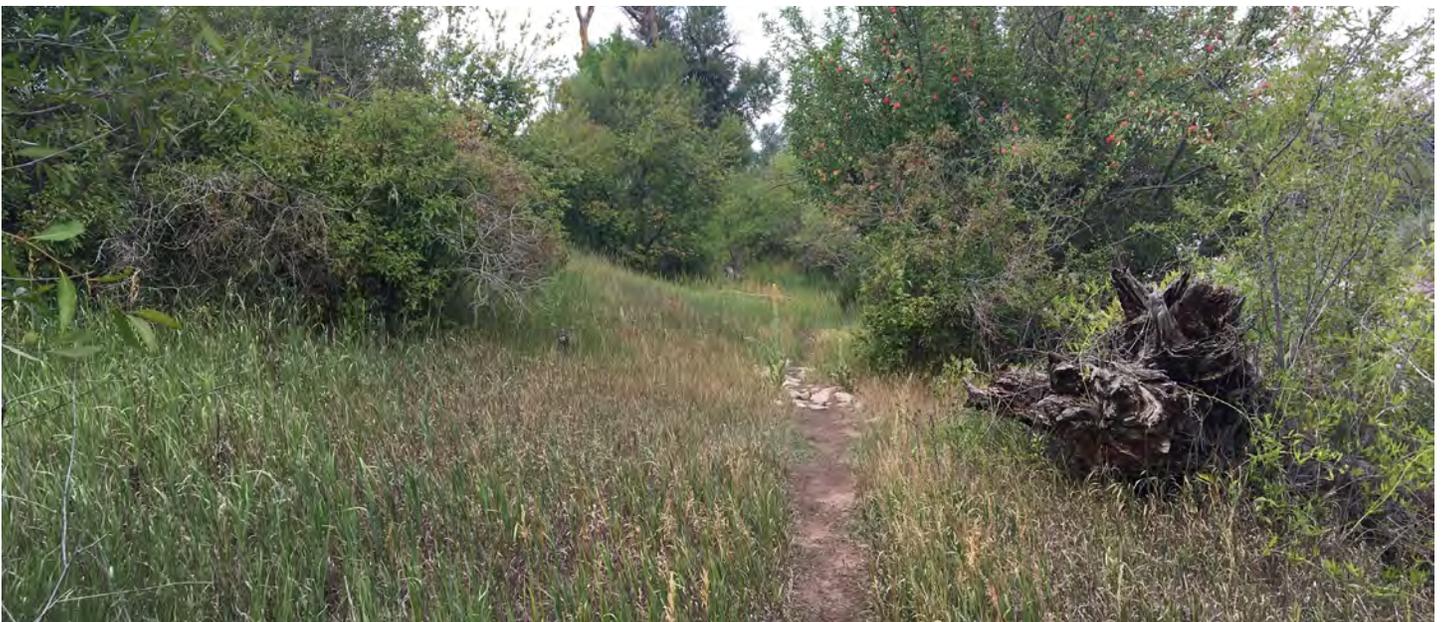
Image 4-5 The shrubs in this image are in good health and these woody vegetated zones are recommended for preservation. The wide swaths of brome in the foreground of the photograph are an opportunity for riparian enhancement.

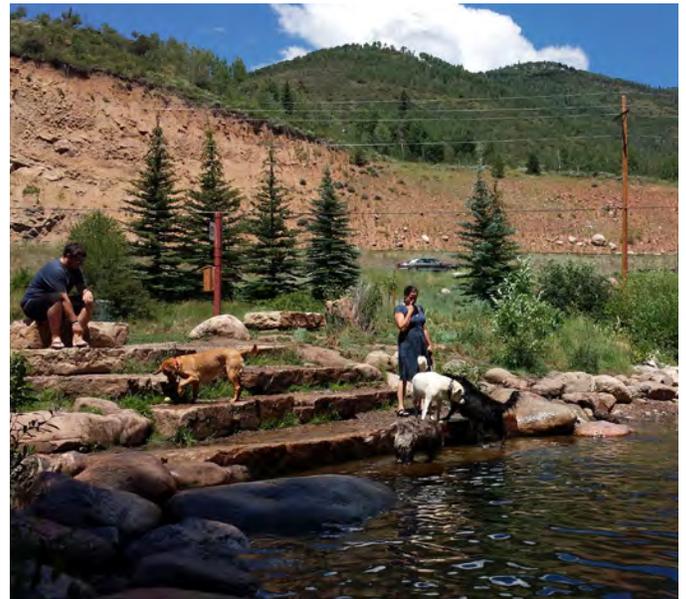
Image 4-6 An example of a bank repaired with boulders and steps

opportunities. In higher traffic and access areas, the bank restoration will be comprised of boulders. Lower traffic area restoration activities will utilize vegetation and large wood, with boulders only used for toe reinforcement. Examples of this type of restoration are shown in Images 4-6 and 4-7. Proposed locations are shown on the maps at the end of this section.

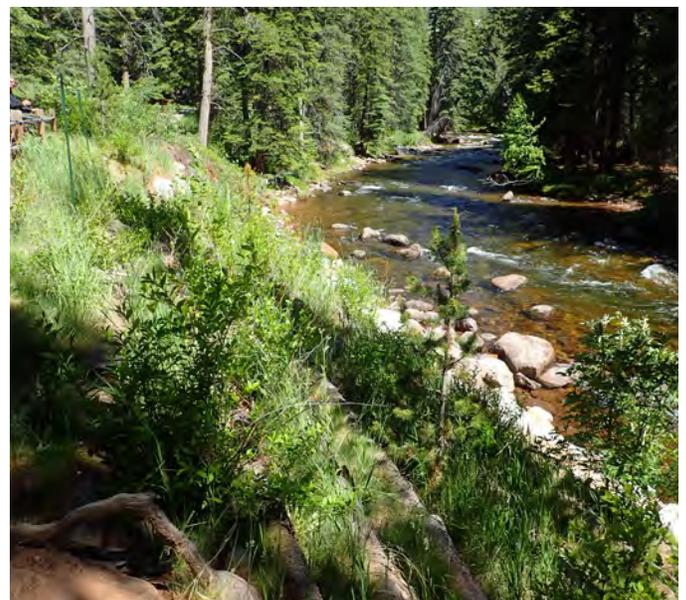
Image 4-7 An example of a bank repaired with vegetation

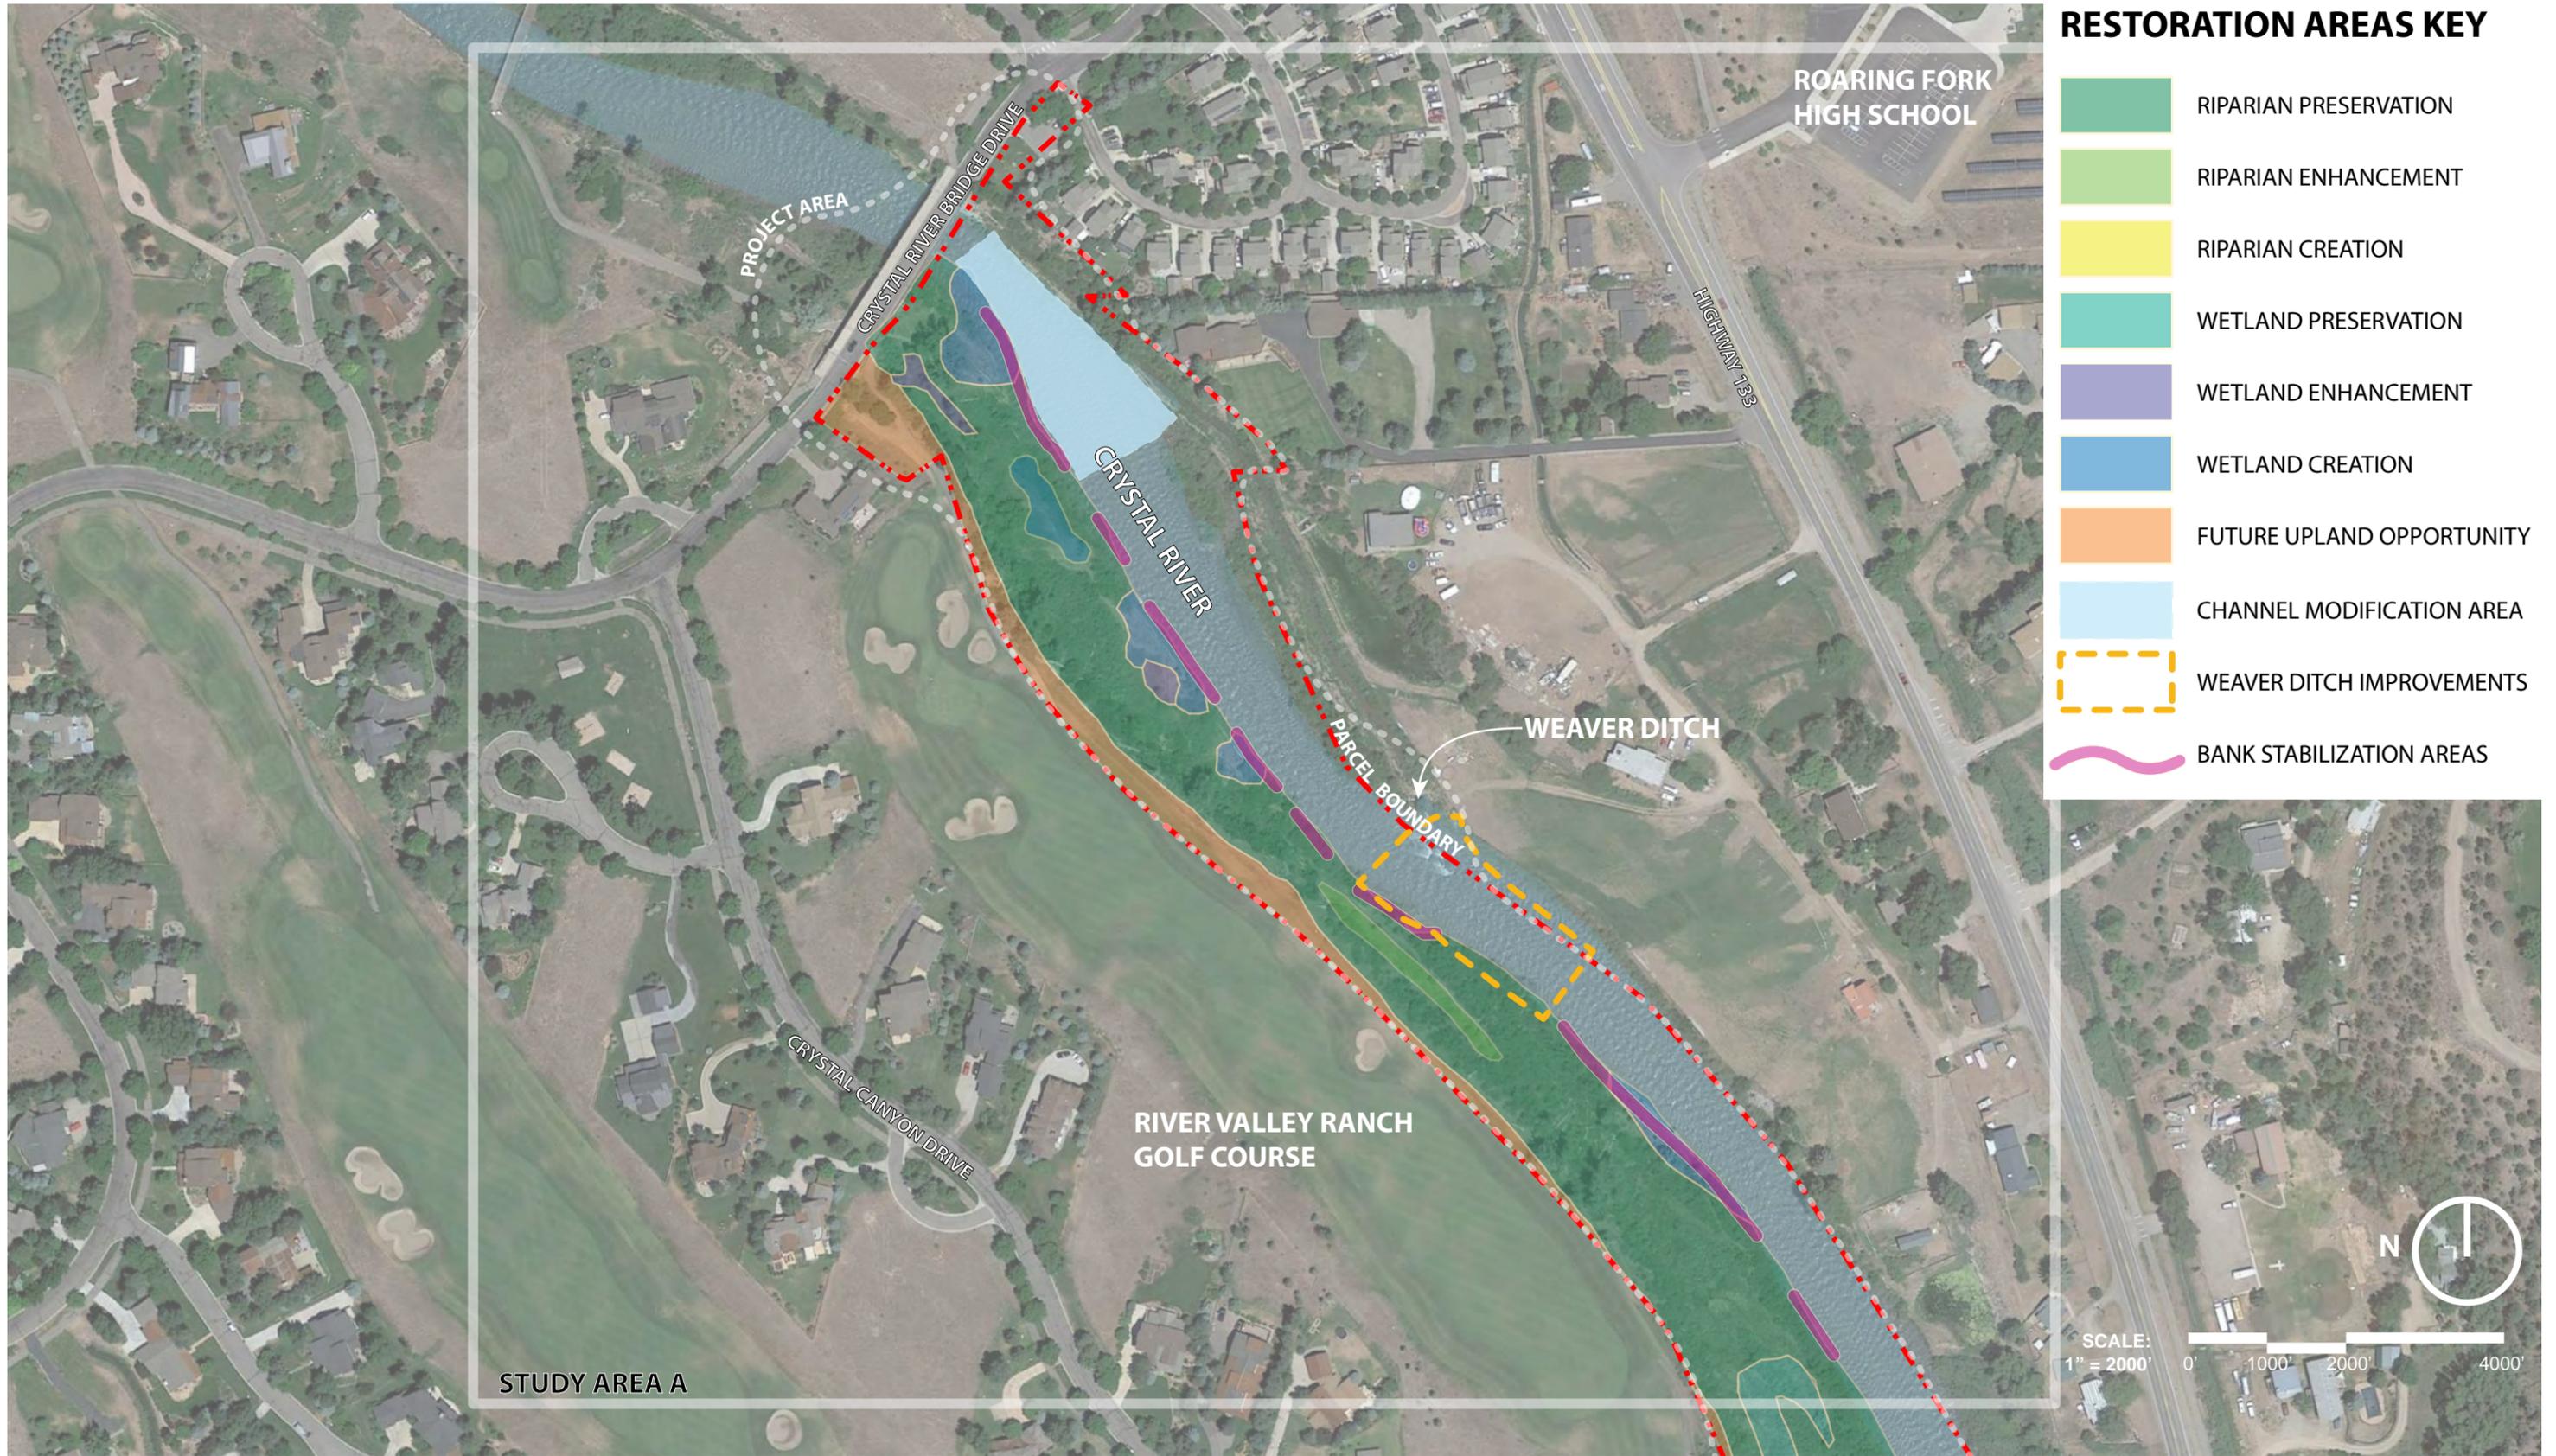
- RIPARIAN PRESERVATION
- RIPARIAN ENHANCEMENT
- RIPARIAN CREATION
- WETLAND PRESERVATION
- WETLAND ENHANCEMENT
- WETLAND CREATION
- FUTURE UPLAND OPPORTUNITY
- CHANNEL MODIFICATION AREA
- WEAVER DITCH IMPROVEMENTS
- BANK STABILIZATION AREAS

Maps of these opportunities can be found at the end of this section. All priorities and decisions about restoration actions should be guided by stakeholder goals and values.
