# CRYSTAL RIVER RESTORATION

RIPARIAN RESTORATION PLAN & ECOLOGICAL INTEGRITY ASSESSMENT  
GARFIELD COUNTY, COLORADO

Prepared for: The Town of Carbondale  
Prepared by: DHM Design Corp. and River Restoration  
311 Main Street, Suite 102, Carbondale, Colorado 81623

November 2018

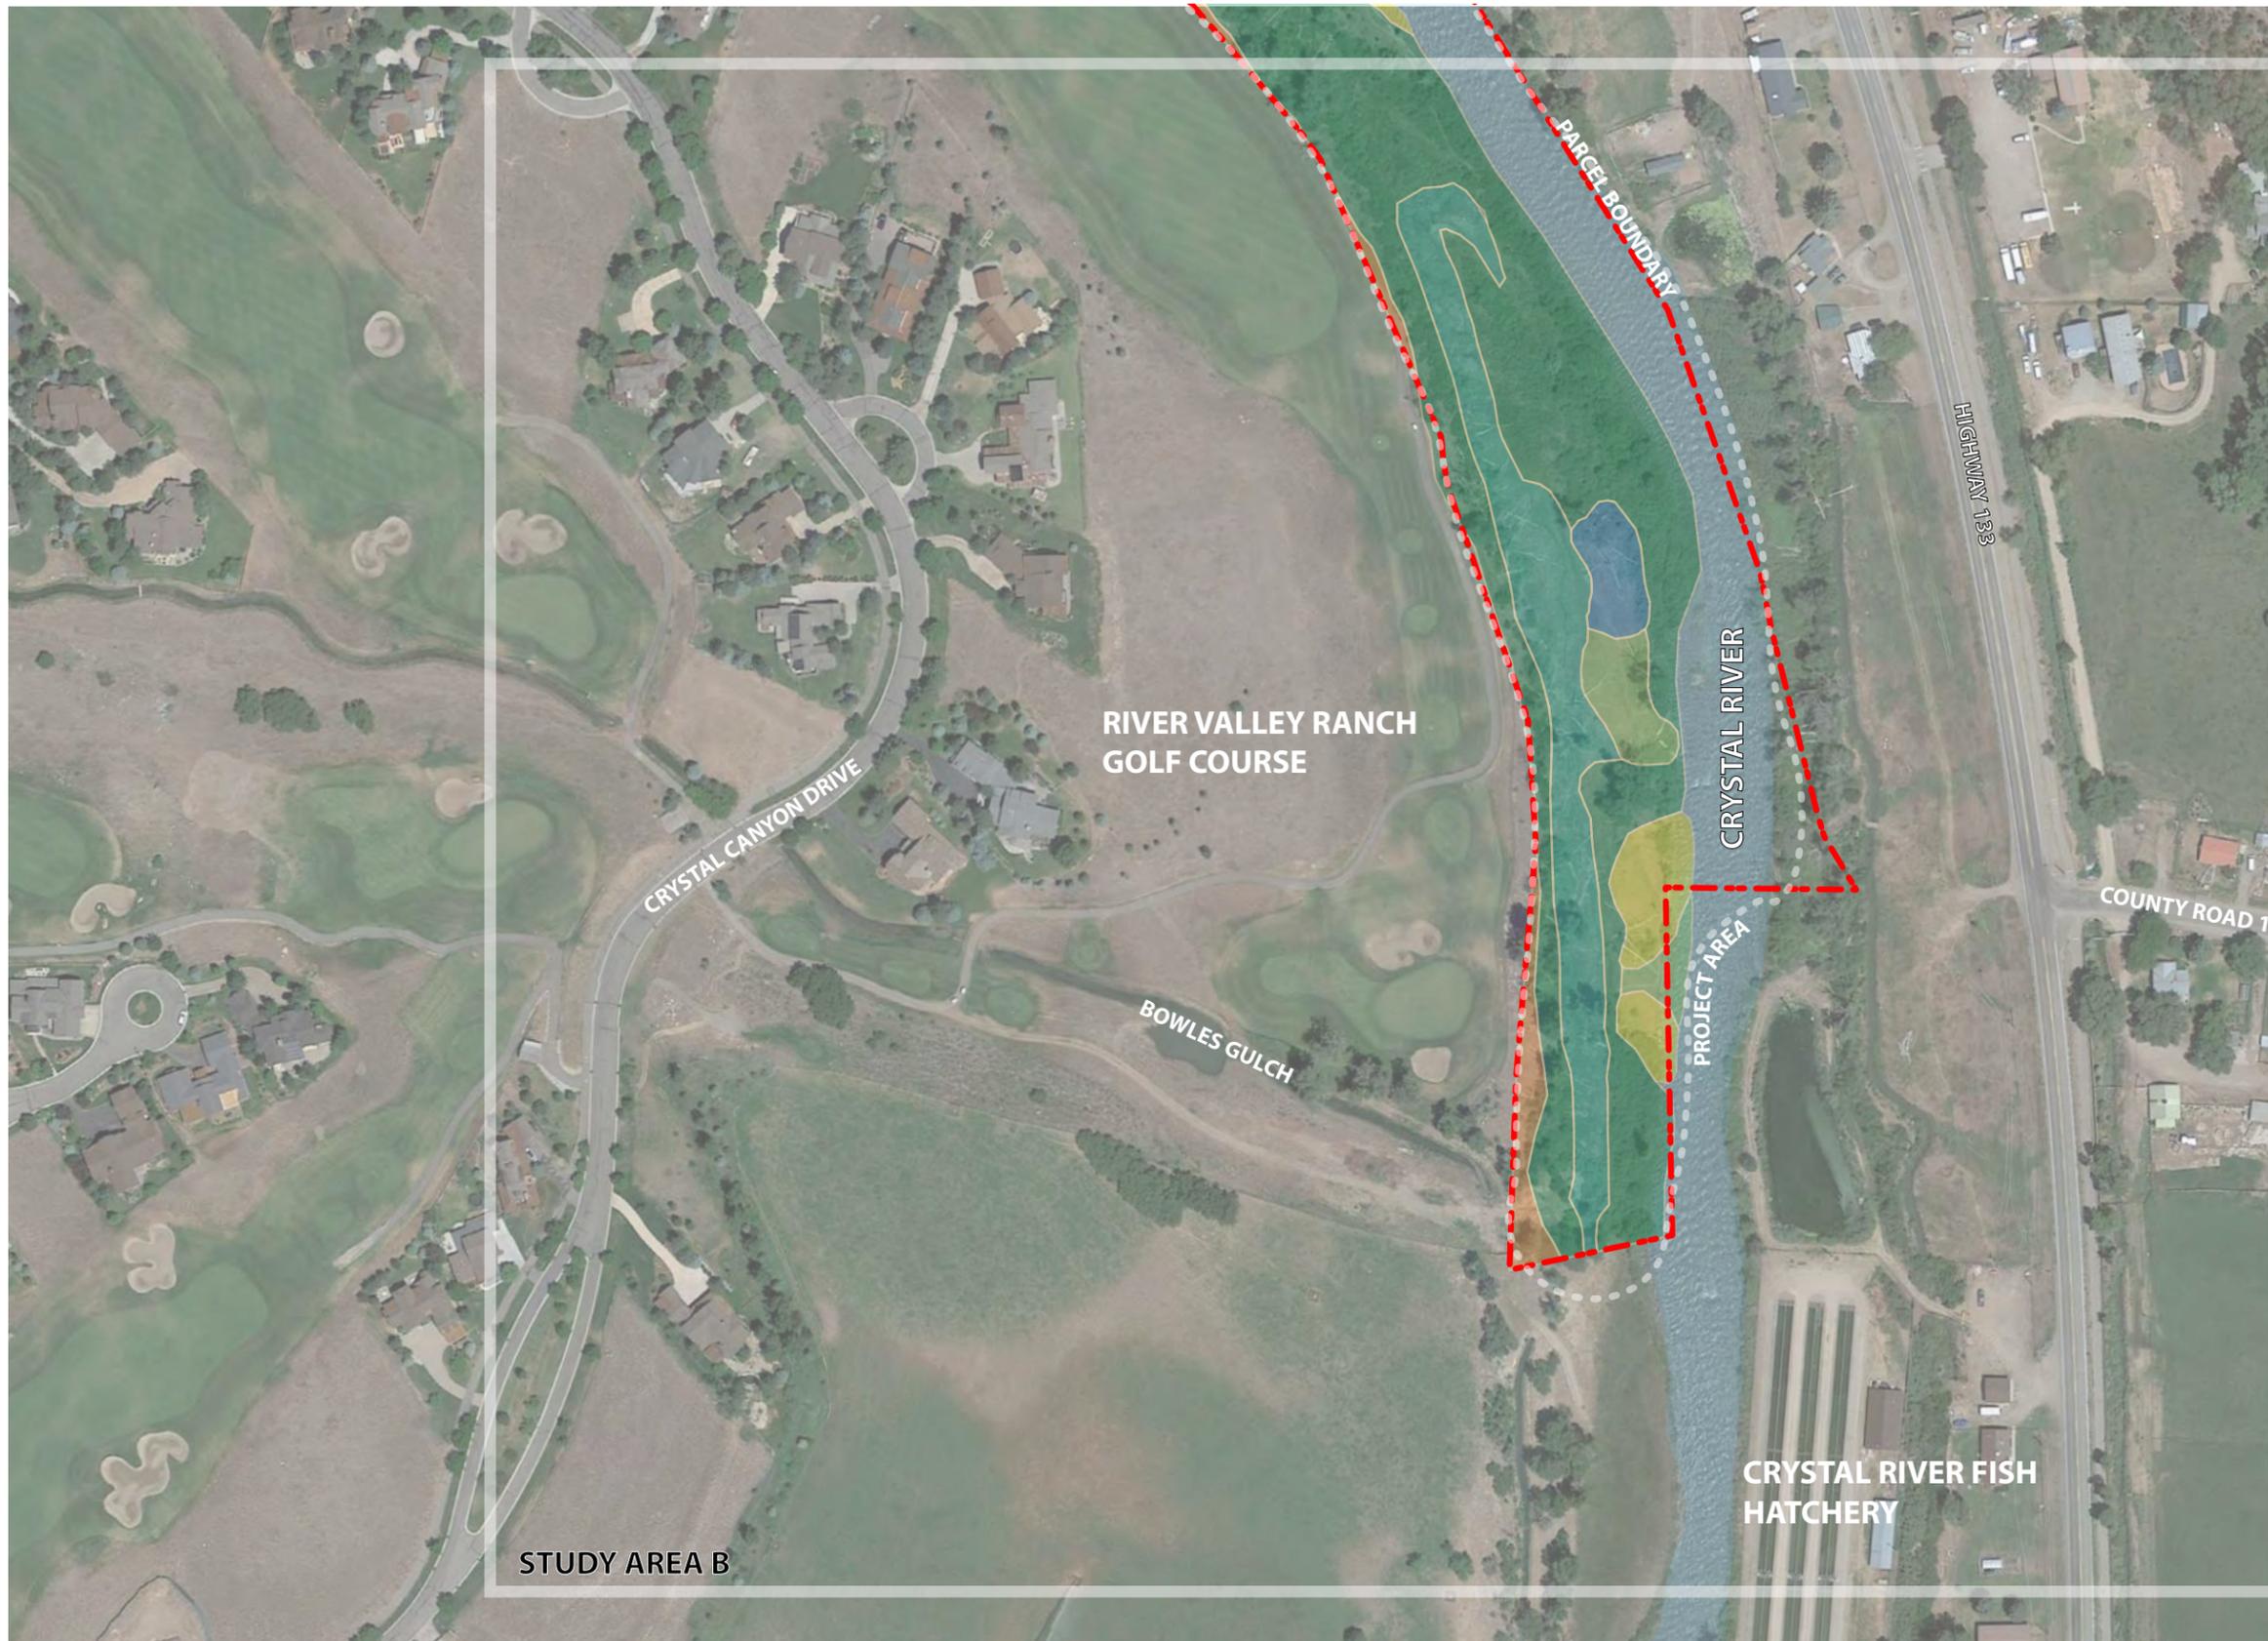
**RESTORATION AREAS KEY**

- RIPARIAN PRESERVATION
- RIPARIAN ENHANCEMENT
- RIPARIAN CREATION
- WETLAND PRESERVATION
- WETLAND ENHANCEMENT
- WETLAND CREATION
- FUTURE UPLAND OPPORTUNITY
- CHANNEL MODIFICATION AREA
- WEAVER DITCH IMPROVEMENTS
- BANK STABILIZATION AREAS

Maps of these opportunities can be found at the end of this section. All priorities and decisions about restoration actions should be guided by stakeholder goals and values.

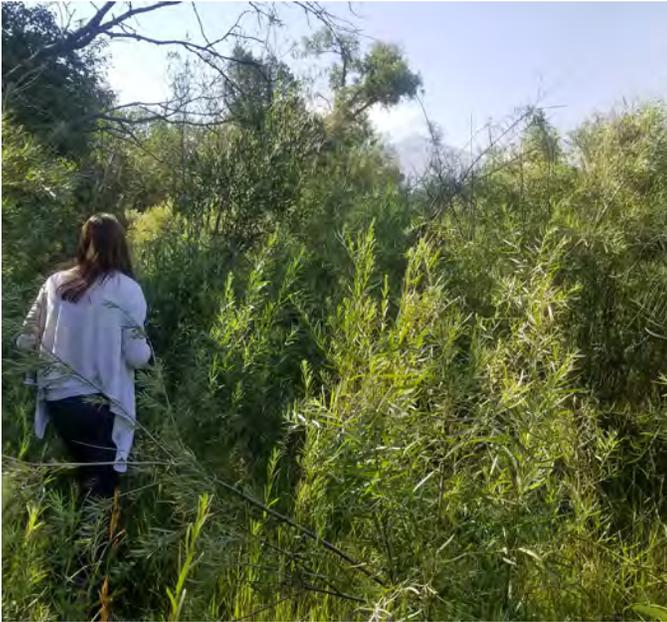
Image 5-3 Navigating the overgrown trail

The main trail along the site is heavily overgrown and can be difficult to locate and navigate. Areas of the trail have eroded into the river and navigation through the overgrowth is difficult in sections. This trail overgrowth and degradation has resulted in informal “social trails” winding through the site and degraded river banks from informal access points contributing to erosion and bank destabilization.

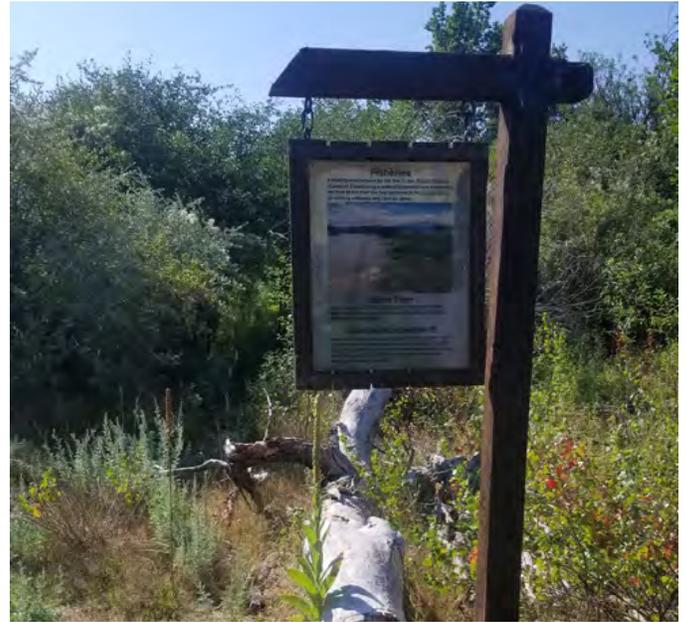
Image 5-4 Example of current interpretive signage

The Project Area contains a number of interpretive signs, however these signs have become worn over time and are dated. Many signs are no longer visible due to vegetation overgrowth and do not describe the ecologies of the locations where they stand. Instructional and regulatory signs are not concentrated or clearly placed near the main access point near the bridge.

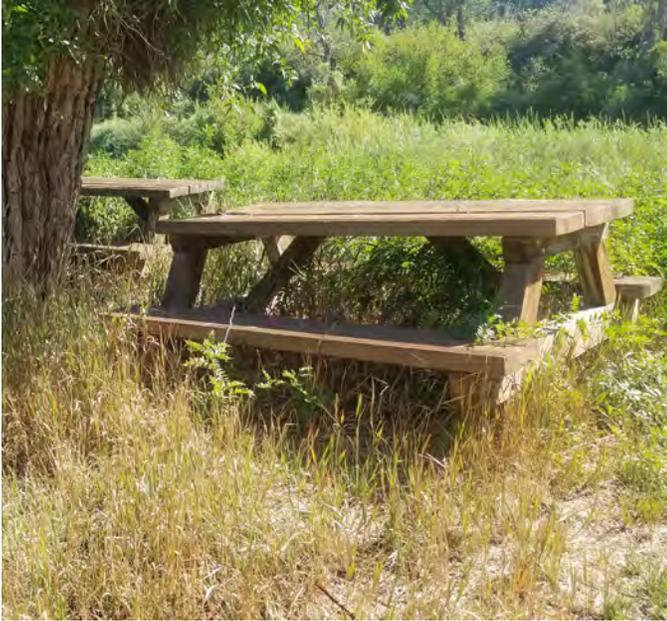
Image 5-5 Picnic benches on South end of Project Area

There are no formal gathering places with the exception of two picnic tables near the south end of the site (see Image 5-5). The area is both hard to locate and in disrepair due to age and lack of maintenance. Several informal gathering spaces exist and are evident in areas where the vegetation has been disturbed.

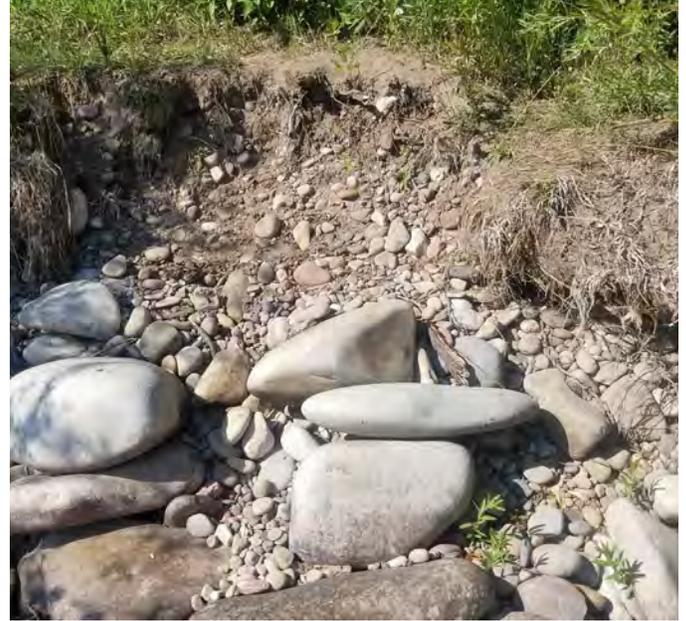
Image 5-6 Informal river access with visible erosion

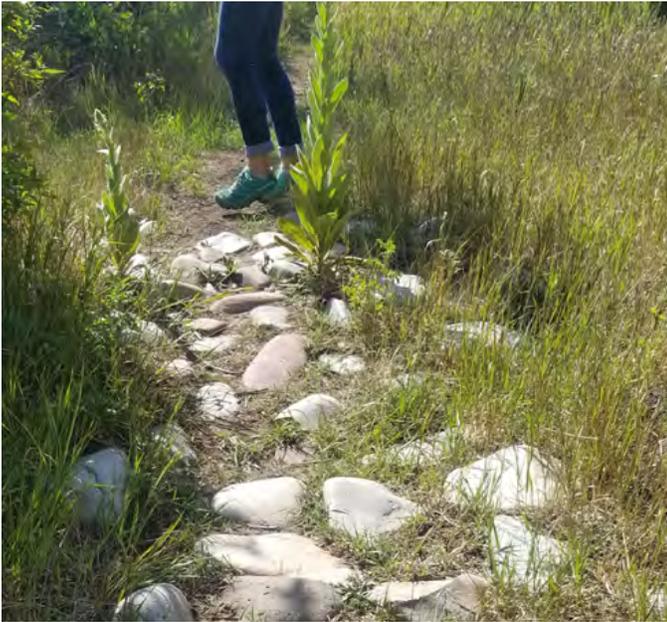
Image 5-9 Navigating the trail can be tricky, the surface material changes through out the site

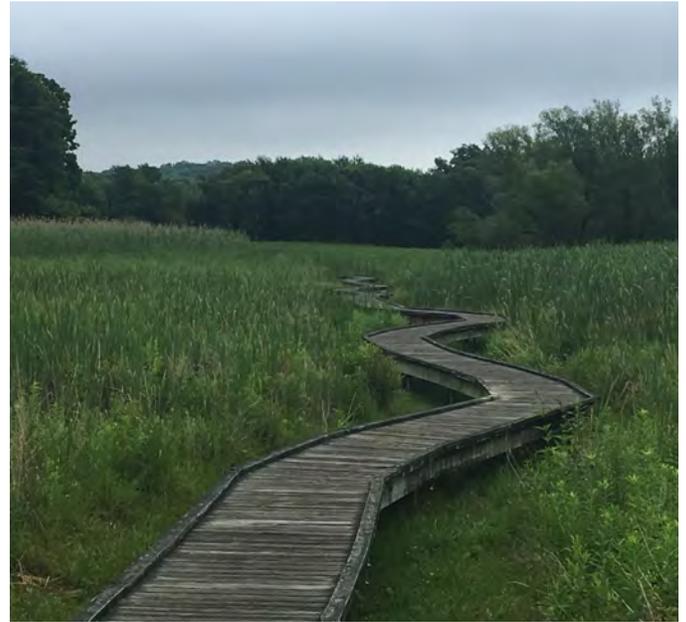
Image 5-10 Example of a boardwalk through an ecologically sensitive area

There are three types of trails which would be most appropriate for the site. The primary trail type would be composed of a wide, firm surface and would connect to the universally accessible public gathering spaces and interpretive, educational areas. This trail would be accessible for less mobile individuals. The second type of trail would be more primitive and narrow. This trail could pass through several existing and healthy riparian areas. Finally, low boardwalks could be used in a few areas such as floodplains, connection areas and the re-established secondary channel.

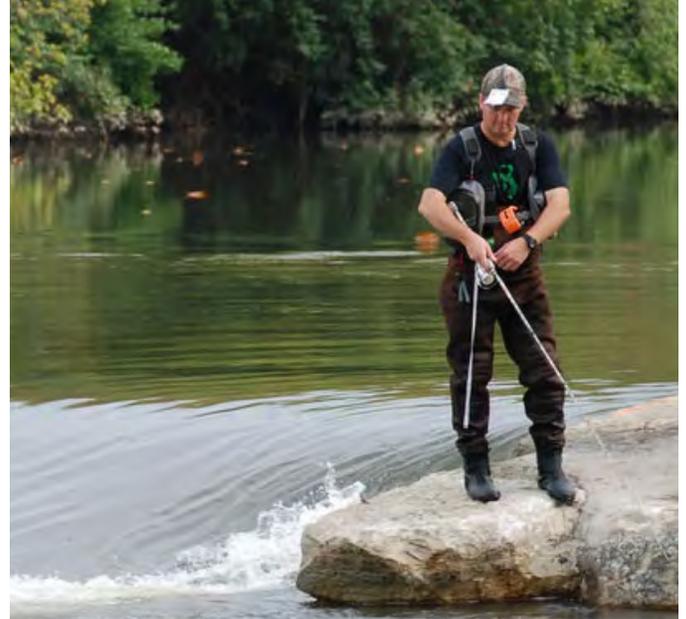
Image 5-12 Example of a durable surface used for river access, helping to prevent erosion, fisheries health and bank destabilization

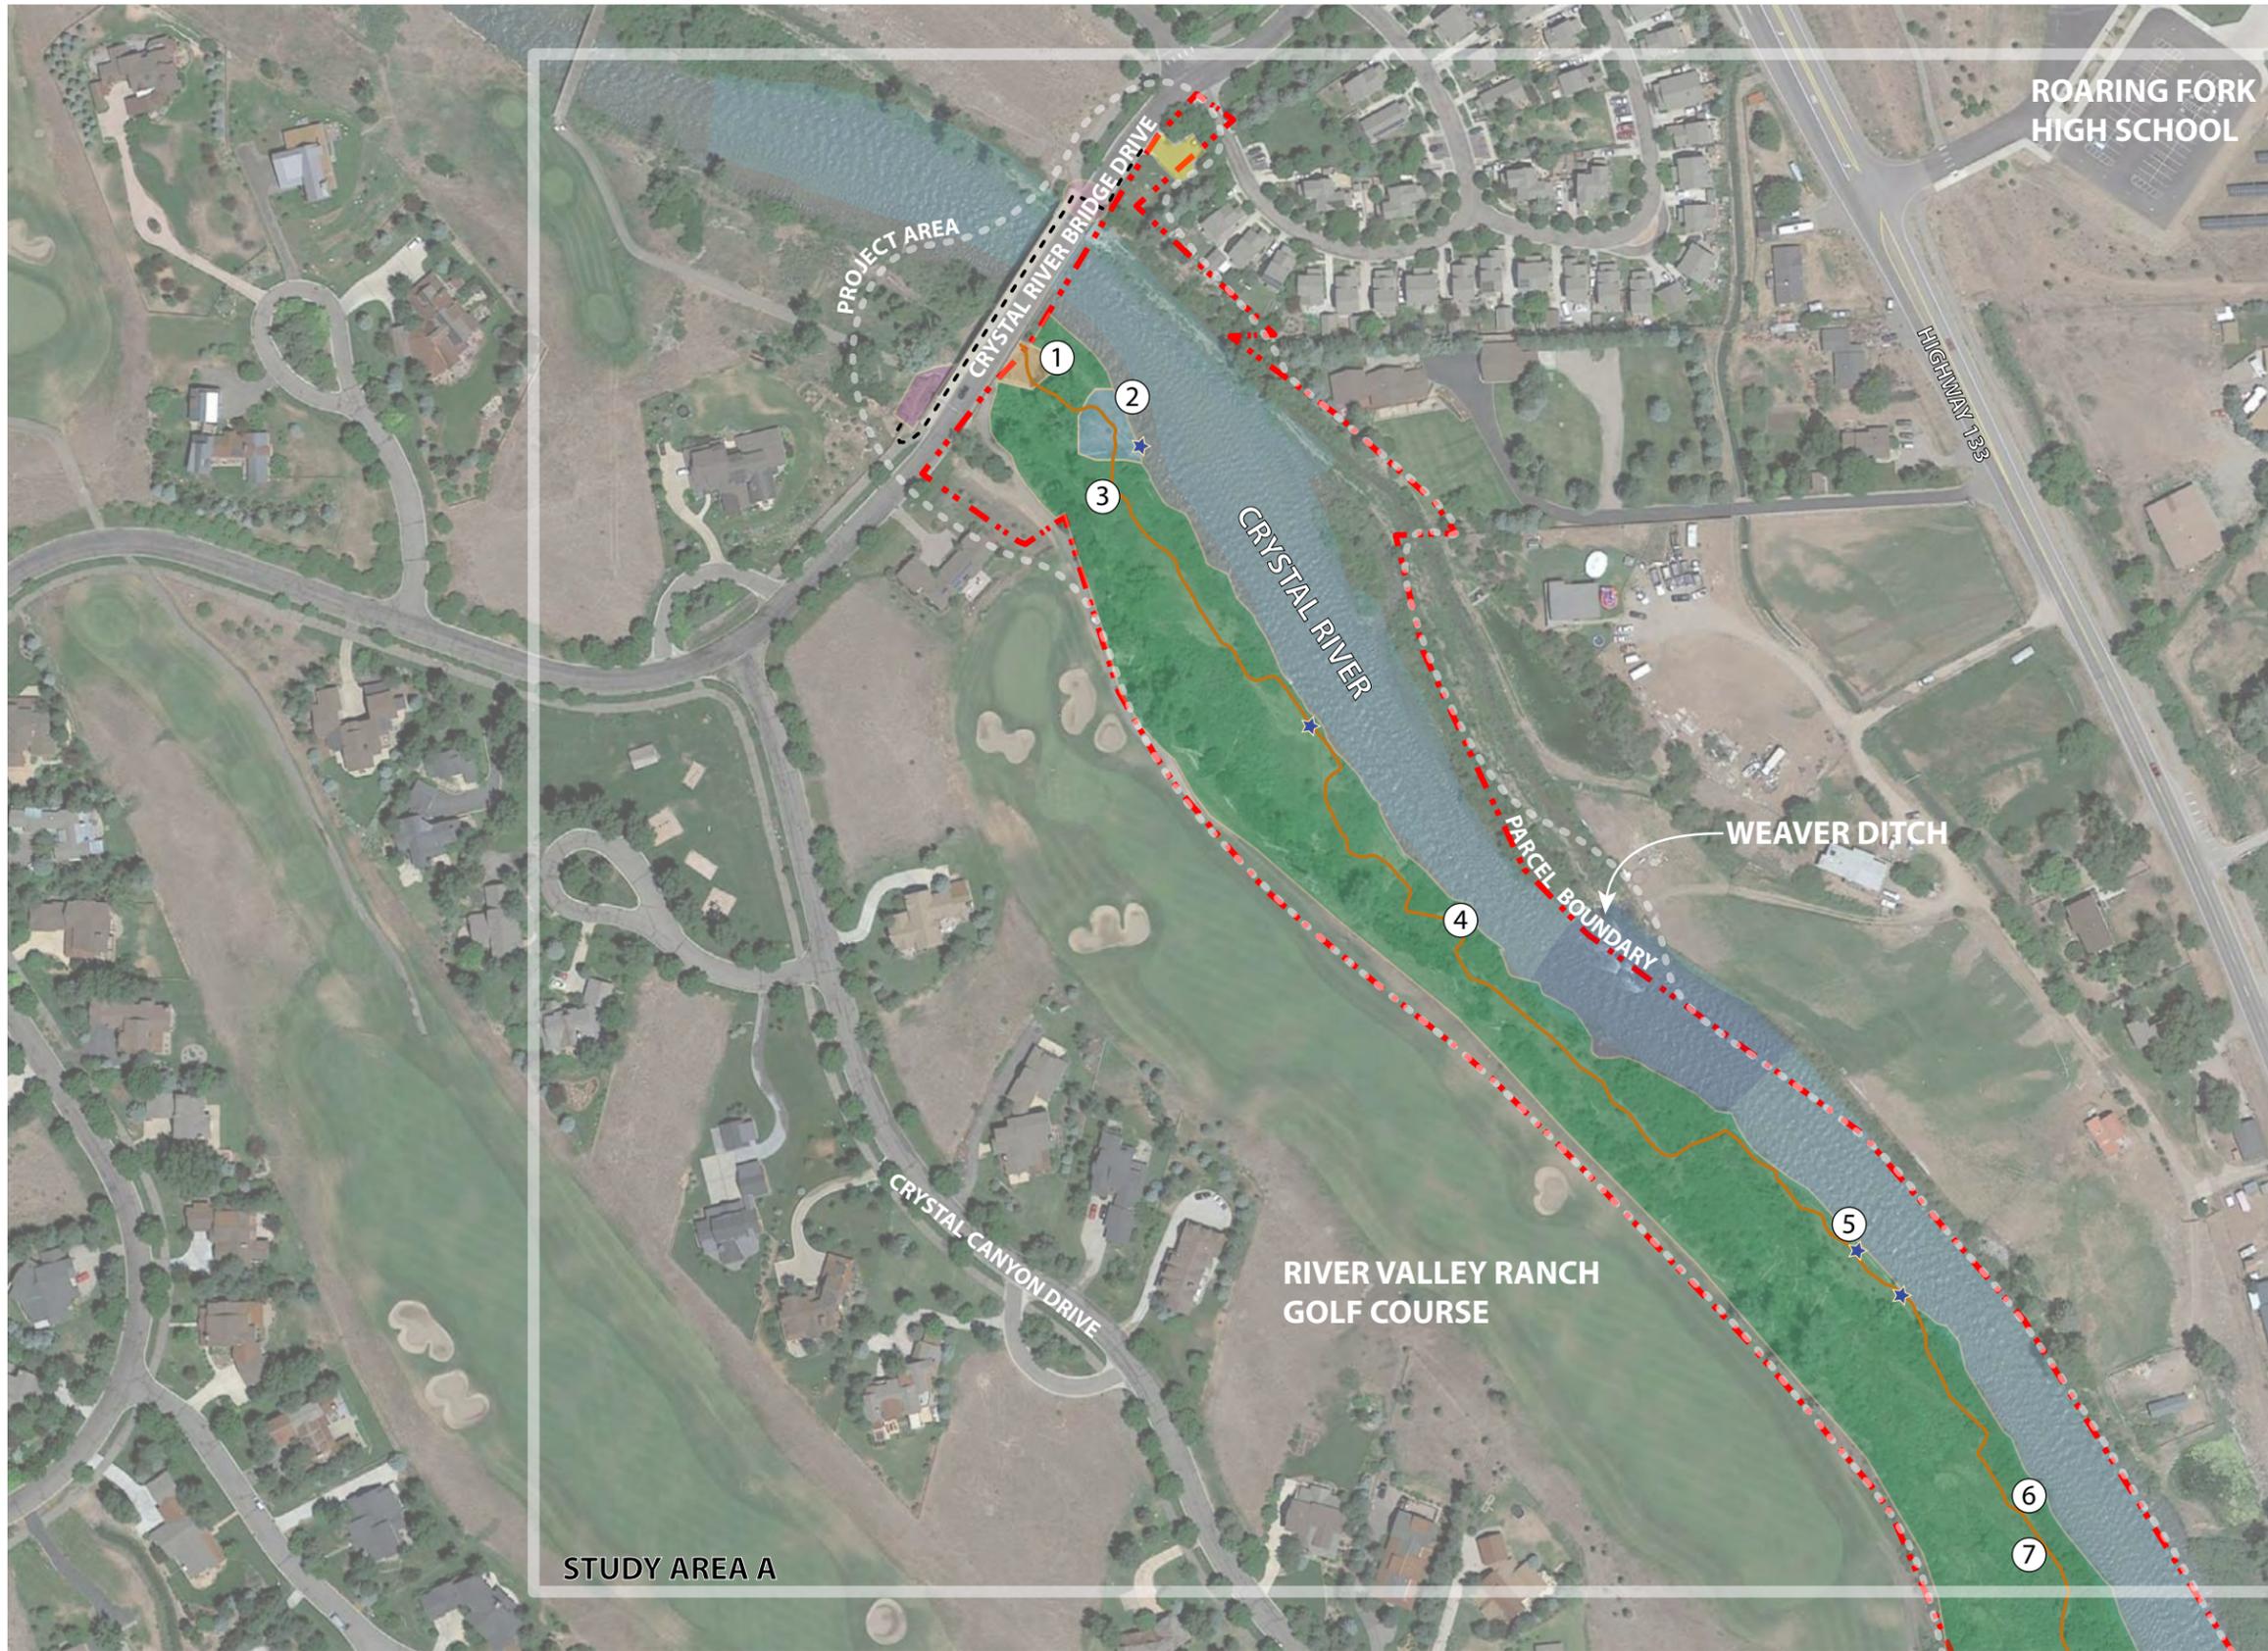
## RECREATION AREAS KEY

- EXISTING PARKING AREA
- PROPOSED IMPROVED PEDESTRAIN CROSSING AND BIKE RACK
- PROPOSED IMPROVED ACCESS AND RAMP
- PROPOSED PUBLIC GATHERING AREA
- ECOLOGIC PRESERVATION ZONE
- PROPOSED WEAVER DITCH REHABILITATION
- PROJECT AREA ACCESS ROUTE
- PROPOSED TRAIL FOLLOWING EXISTING ALIGNMENT
- PROPOSED FORMALIZED RIVER ACCESS POINT
